# Repairing native defects on EUV mask blanks

Mark Lawliss<sup>a</sup>, Emily Gallagher<sup>a</sup>, Michael Hibbs<sup>a</sup>, Kazunori Seki<sup>b</sup>, Takeshi Isogawa<sup>b</sup>,  
Tod Robinson<sup>c</sup>, Jeff LeClaire<sup>c</sup>

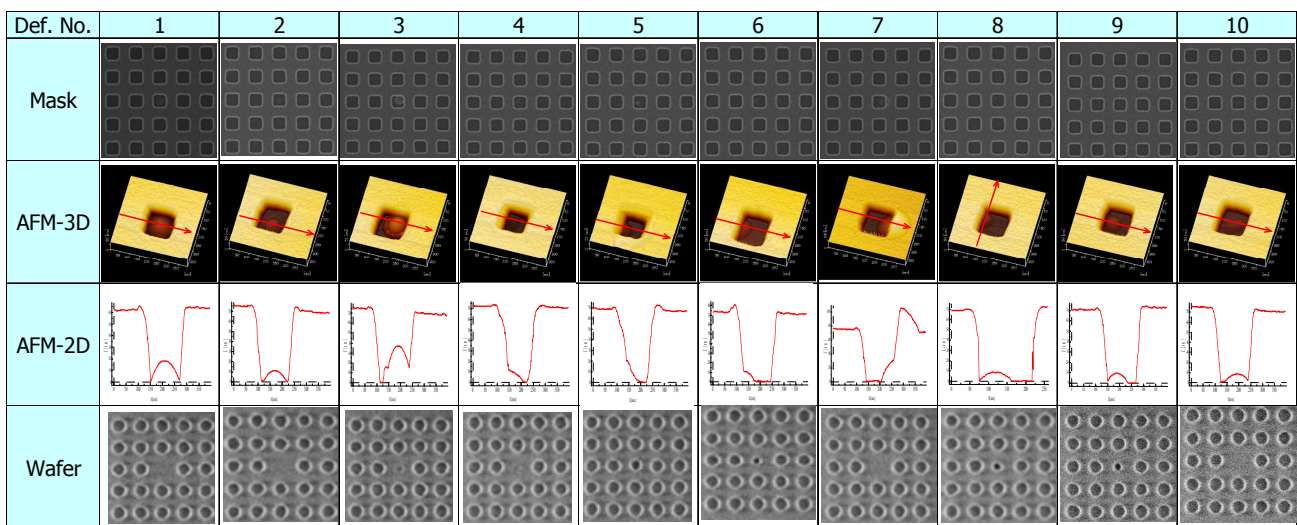
After mask characterization, several defects were selected suitable to include in this work. In almost every case, the defect found at blank inspection was well-centered in a 5x5 array of contacts. In Figure 3 below, the set of defects used for repair testing is shown. In each case, the defect is easily mapped with one contact feature and the wafer print has significant error.

**Figure 3.** Ten blank defects used for repair testing are shown. All were contained within one feature and are clearly visible in the AFM images in rows 2 and 3. Row 4 shows Pre-Repair wafer prints. Some of the defects print as a completely missing contact on wafer, while some print as a reduced contact size on wafer.

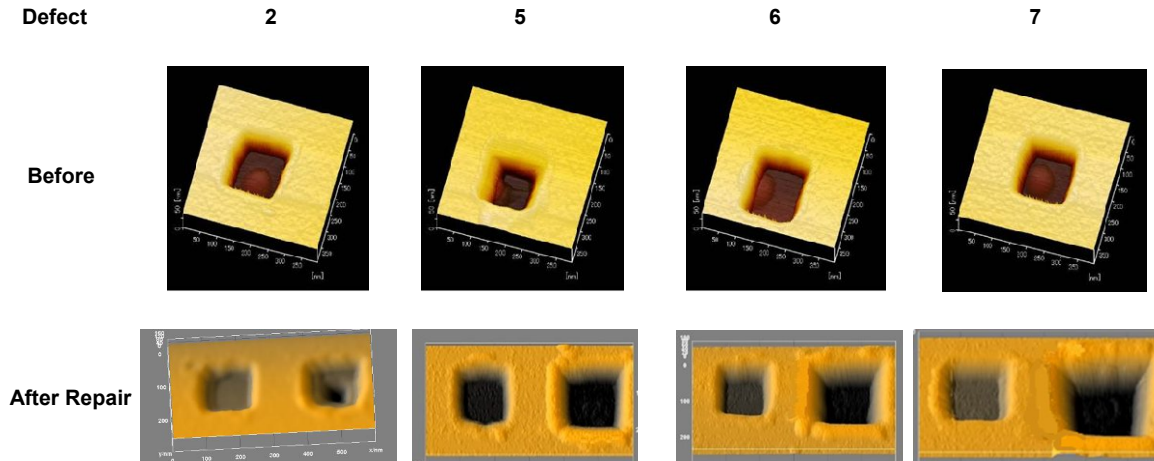
**Figure 7.** The scans show four repairs, the initial defect is on the top row and a pair is provided after repair so that a reference (left) and the repaired site (right) can be compared. Only the contact on the far left was repaired using test process #B in which a targeted depth of 70nm was achieved with nanomachine repair. The other three sites were repaired using repair process #A. Both the contact size and depth are increased with nanomachine repair. Please note that some scans show ghost artifacts from the software and AFM scan methods used.

All repair work described here was accomplished using a nanomachine repair method. This method has a known strength of removing material of unknown composition to aggressive targets. Both the depth and lateral edge absorber bias repair tolerances were set to  $<3\text{nm}$  for all sites. The resulting repairs achieved these tolerances, with the range of depths  $0\text{nm}$  to  $58\text{nm}$ , and the edge absorber bias  $0\text{nm}$  to  $58\text{nm}$ . The range of repair bias in this work was an initial choice, but larger biases may ultimately be required. The repair parameters for repair process #B, including the  $70\text{nm}$  depth target, were provided by wafer simulation. None of the repairs, including repair process #B, required the high aspect ratio nanobit to meet the  $\pm 3\text{nm}$  tolerance. The majority of the process debris created by the repairs was removed with the BitClean process available on the same system used to do the repairs. Figure 7 below shows the scan image results on four sites. The contact on the left scan used repair process #B removing multilayer in the area around the original defect area, while the contacts in the other scans used repair process #A removing multilayers across the whole contact. The print results shown in Section 4 were not constrained by repair process control.

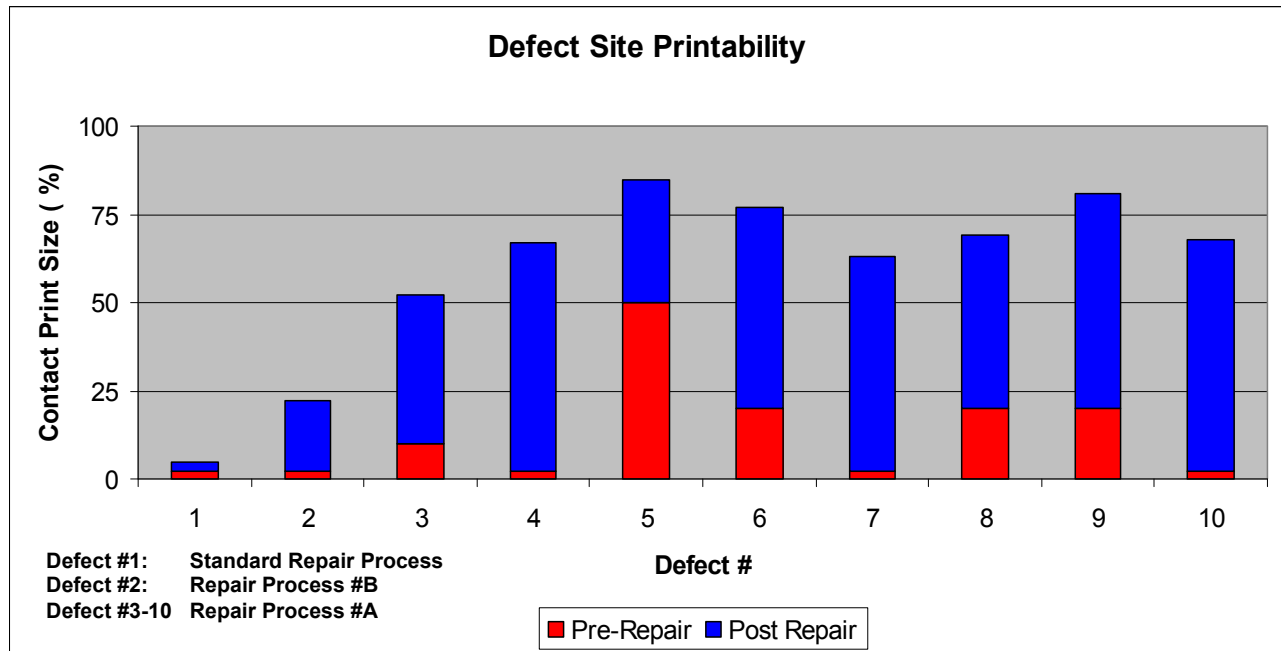
A graphical representation of the data is shown in Figure 8. The red bar represents the pre-repair CD size as a percentage of reference target. The blue bar is the same measurement after repair. The desired result is for the blue bar to reach 100%. The first important result is site 1, which used the standard repair process with very small bias in depth and little absorber edge bias. For this site, the site printed a missing contact both before and after repair, indicating that standard methods will not be effective on blank defects. Every other site shows improvement after repair. A few of the sites approached the 100% CD print target.

The other site of note is defect #2. This site was repaired using the repair process #B strategy based on wafer simulation software input. Repair process #B was a targeted depth bias covering only the area of the original defect rather than the whole contact. While the print CD size did improve, the amount of improvement was less than achieved on all repair process #1 sites. The most obvious next step on this site is to increase the lateral edge absorber bias beyond the amount indicated by the simulation. So far, repair process #A is more effective in improving printability. As previously discussed, contact repair is challenging, but these results suggest a path forward.

**Figure 8.** This bar chart shows the pre-repair and post-repair contact print size by percentage for the ten sites measured. Each site showed printability improvement, except for site 1, which used the standard repair method.

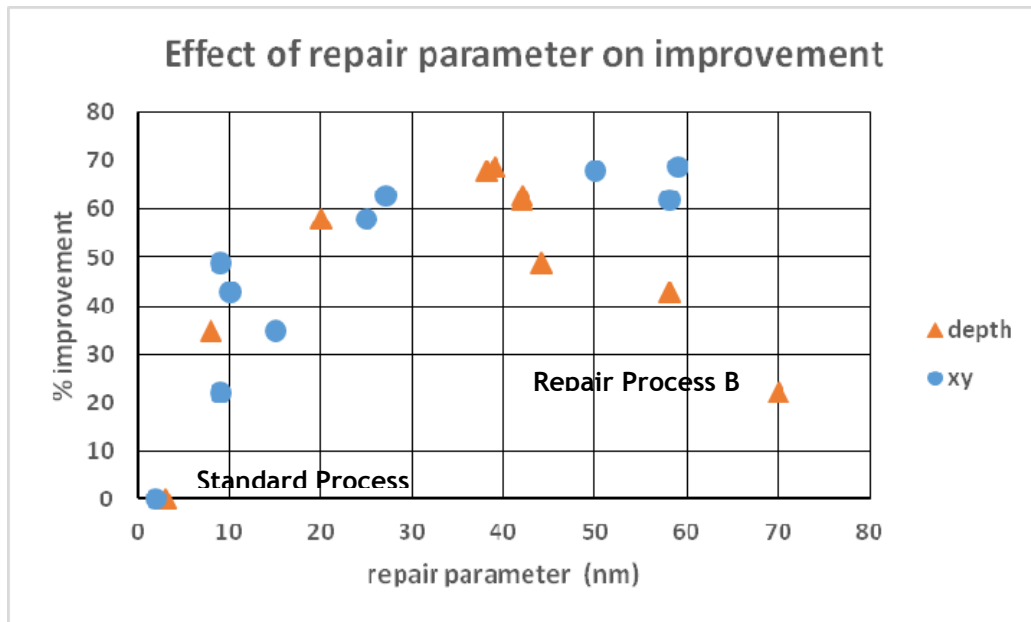
Figure 9 plots the same data. In this chart, each site is analyzed for CD error % improvement after repair, and is graphed against both depth bias and XY edge absorber bias. This graph shows a trend of greater CD error % improvement with higher repair bias. The XY edge absorber bias shows a much stronger trend.

**Figure 9.** This graph plots the post repair print improvement (% improvement) versus both depth bias (nm) and lateral edge absorber bias (nm). Both parameters show a positive trend with the absorber bias trend stronger.

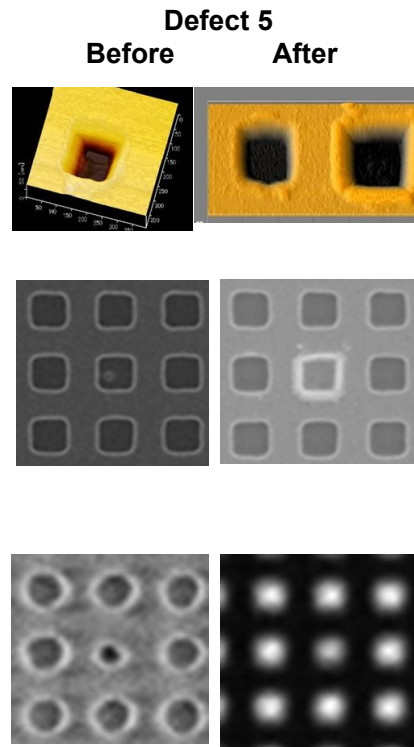
**Figure 10.** The images show defect #5 both before and after repair. The top row shows the AFM image of the site. The center row shows the SEM image of the site. The bottom row shows a wafer print of the site before repair and an EUV microscope image of the site after repair. The printability of this site has improved by almost 30%.

The repair site that gave the best final printability image was defect #5. This site was repaired using repair process #A. Figure #10 contains some images of the site, both before and after repair.
