Mask blank defect printability comparison using optical and SEM mask and wafer inspection and bright field actinic mask imaging

ABSTRACT

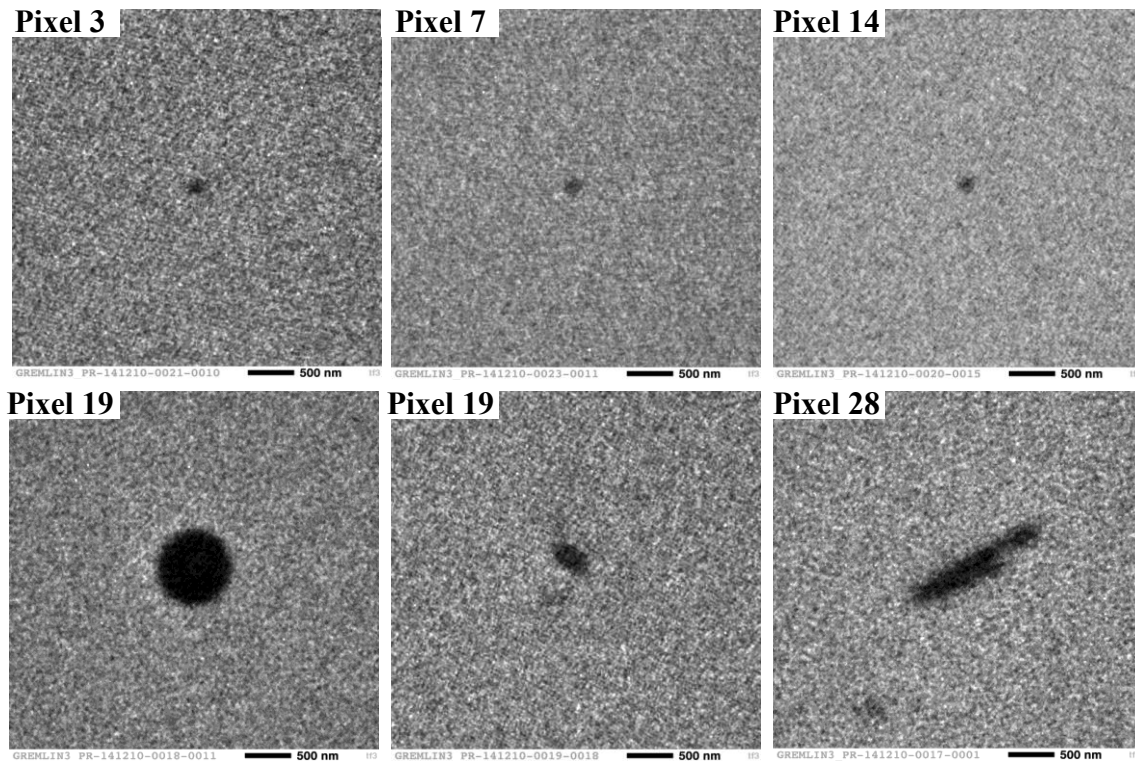
Figure 1. Actinic images of defects in the dark, absorber region of GREMLIN3-PR. The "pixel" values indicate the size assigned by M1350 inspection. Scale bars are all 500 nm.

Within the patterned area, 14 defects were identified and imaged. The majority of these defects were classified as belonging to the smallest pixel bins (i.e. 1 to 4), corresponding to defects below 60 nm. Many of these defects were missed in the previously reported work that was based on just the optical mask and wafer inspection [9]. With the clear appearance of these defects at-wavelength, the actinic imaging shows that pixel 1–4 defects cannot be excluded from the defect mitigation strategies.

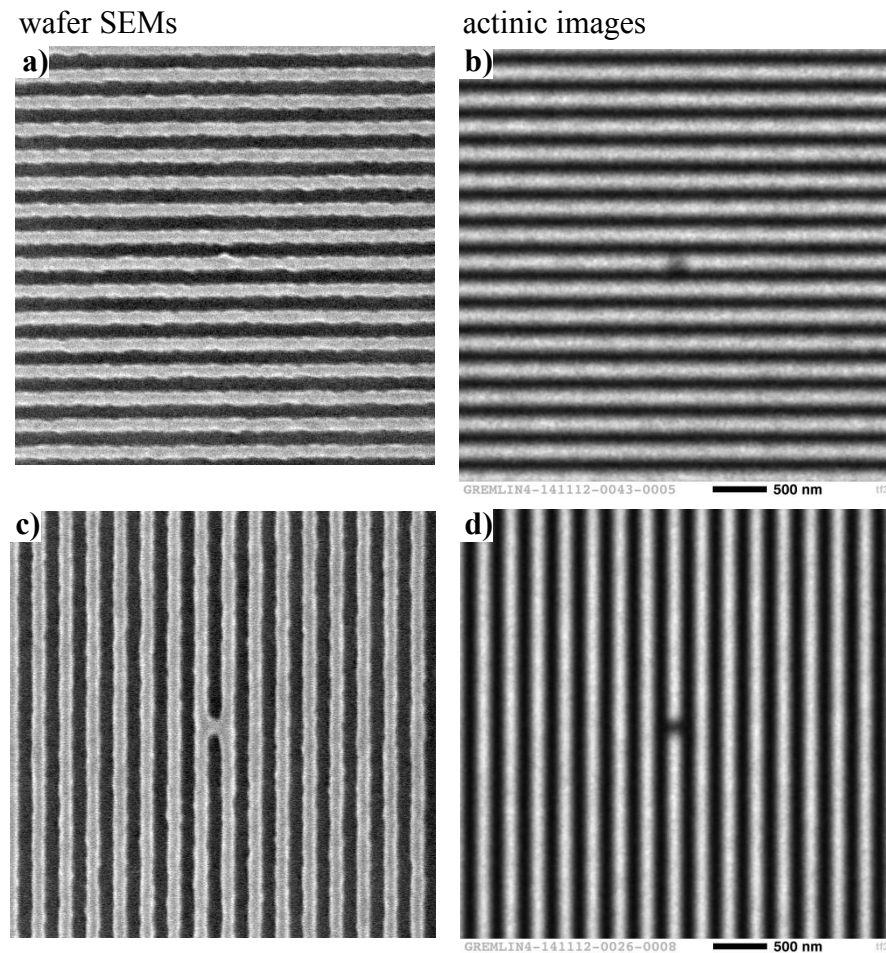
Figure 2. Unbridged (a, b) and bridged (c, d) defects, comparing wafer prints (a, c) to actinic images (b, d) respectively.

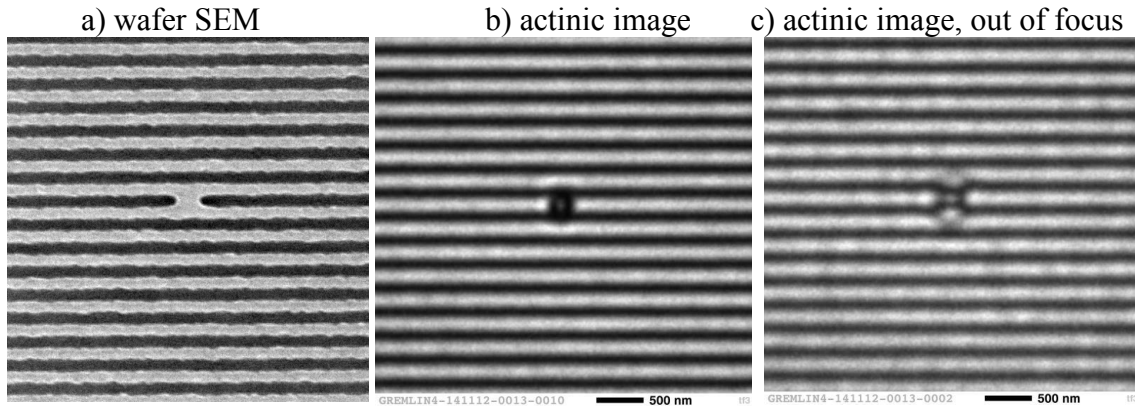
Figure 3 shows one defect that was clearly identified as phase defect. It was identified in the wafer print but missed on the mask in optical inspection. Twenty-four blank defects were not

Figure 3. Comparison of wafer SEM and actinic images. The through-focus behavior of the defect in the actinic images shows that this defect has phase-shifting properties in addition to amplitude changes.

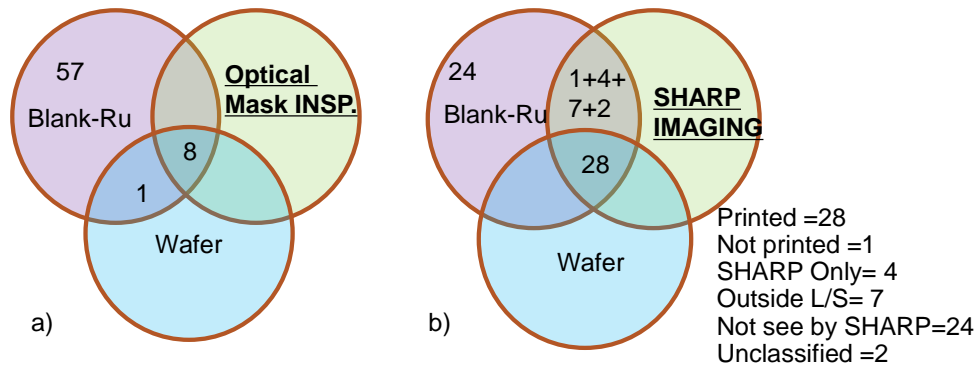
Printed =28
Not printed =1
SHARP Only= 4
Outside L/S= 7

Not see by SHARP=24
Unclassified =2

Figure 4. Comparison of mask images, correlated using optical vs. actinic imaging.

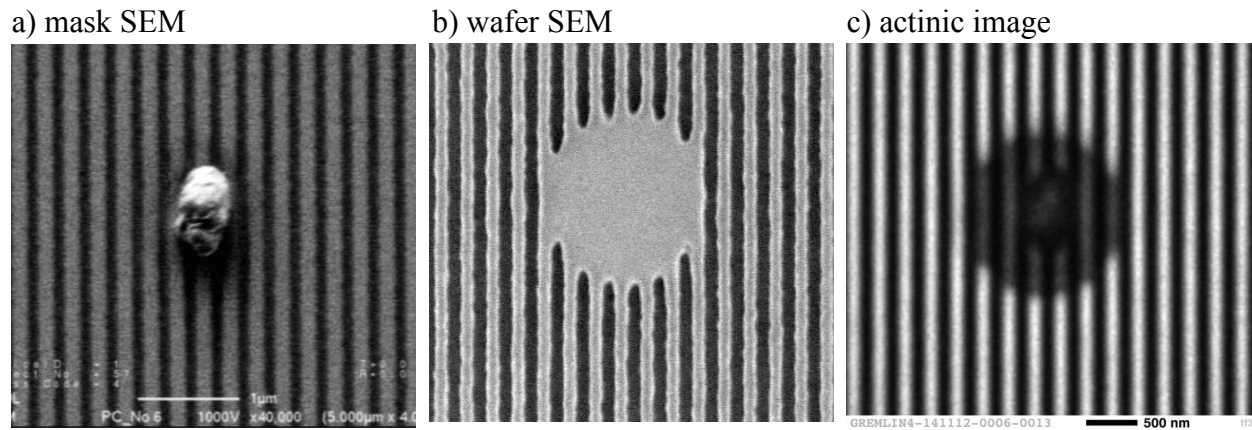
Additionally, actinic review reveals the impact of multilayer damage and depicts the printability profile, which can be used as an added metric to define the patterned mask repair and defect compensation strategies. Figure 5 shows an actinic image, mask SEM image and the wafer print of one defect. Without the actinic imaging, it will be difficult to link the mask SEM image of defect to the wafer print, as the magnitude of the printed defect is significantly different. But, once the actinic image is compared, the defect can be correlated. Furthermore, damage to the multilayer reflectivity is captured both by the SHARP and wafer print but is not evident in the mask SEM imaging. Such additional information is clearly helpful to define mitigation strategies.

Figure 5. Comparison of (a) mask SEM, (b) wafer SEM, and (c) actinic imaging of a large defect, revealing that the actinic image captures fine details not seen by mask SEM.
