The effects of radiation induced carbon contamination on the performance of an EUV lithographic optic

Anton Barty
Lawrence Livermore National Laboratory
PO Box 808, Livermore, CA, 94550

Kenneth A. Goldberg
Centre for X-ray Optics, Lawrence Berkeley National Laboratory
Berkeley, CA, 94720

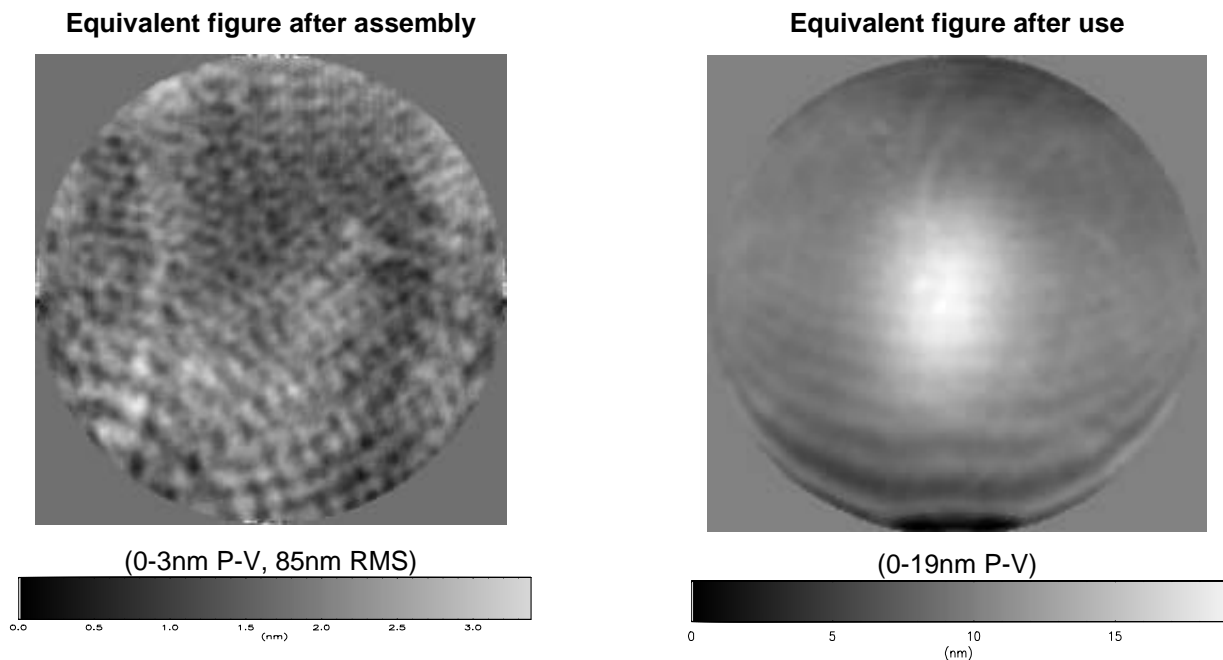
Degradation in the performance of one of the 10x cameras was observed over time and attributed to the optical system, which was removed for analysis and realignment using the visible light interferometry. This visible light realignment and interferometric analysis indicated the presence of a 18-19nm bump in the centre of the optic which was not previously observed when the optic was first aligned. The system wavefront map as measured using visible light interferometry in November 2001 is shown below in Figure 3: on the left is the measured system wavefront at both visible and EUV wavelengths after initial assembly, and on the right is the system wavefront measured in November 2001 using visble light.

Figure 3
System wavefront of the 10x camera, represented as equivalent optical figure on the primary mirror, as measured using visible light (533nm) interferometry after initial assembly (left) and in November 2001 after use in a comparatively hydrocarbon-rich environment ($P_{HC} \approx 10^{-7}$ torr).

19nm is a significant amount of wavefront error and would be expected to cause a significant amount of degradation in the lithographic performance of the optic. However, the observed EUV printing performance of the camera strongly indicated that the EUV performance of the camera was not as bad as one would expect from a 19nm figure error on the optic. There was therefore a discrepancy between the measured system wavefront and the observed lithographic performance of this optic. The 10x camera had been used in a comparatively hydrocarbon rich environment, where the hydrocarbon partial pressure is of the order of 10^{-7} torr, thus accelerated carbon deposition is to be expected. One possible explanation for the difference in visible light and EUV performance is therefore the presence of carbon deposition on the surface of the optics: carbon is more transparent to EUV than to visible light so the effect of this bump on the wavefront would be less in the EUV region than in the visible.

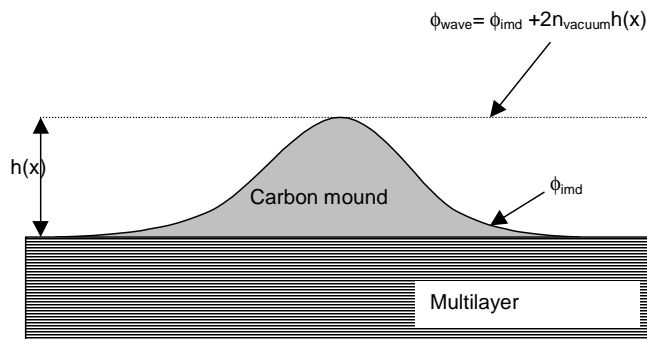
Figure 4

To model the effects of carbon deposition on the multilayer optical performance we deposit a Gaussian-shaped bump of carbon with the optical constants listed above on a Mo/Si multilayer mirror and compute both the amplitude and phase of the reflected wave across the region of carbon deposition, as shown in Figure 4. For simplicity a multilayer of 50 bi-layer periods with no interface roughness and a 4nm thick surface SiO_2 oxide layer is assumed.

Carbon mound on an EUV multilayer used for modelling the effect

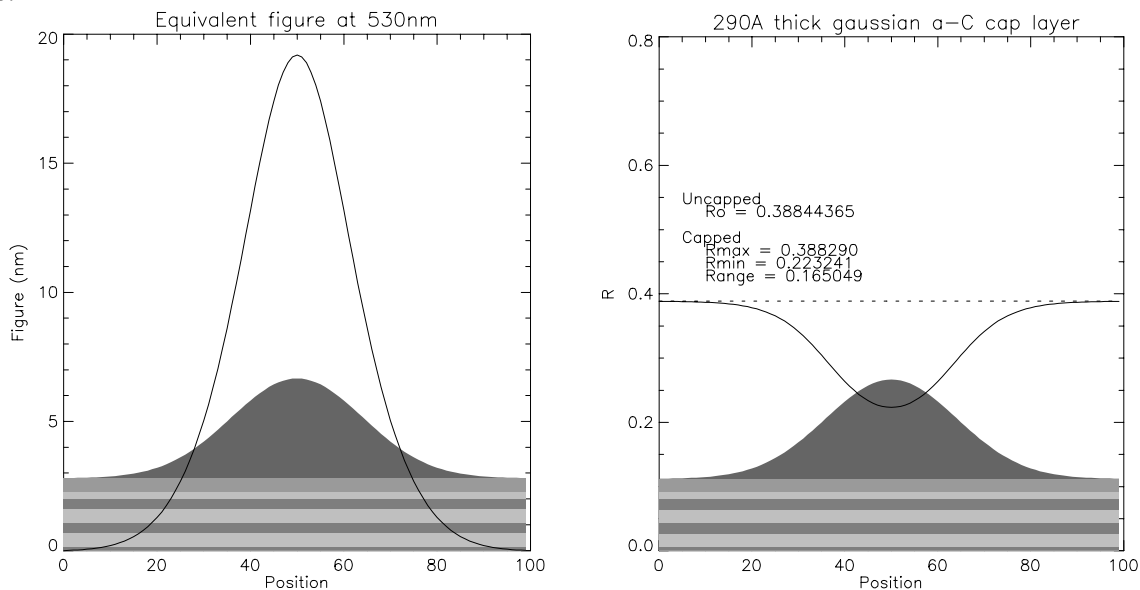
observed figure error we quickly find that a 29nm thick deposit of graphitic carbon produces a 38nm phase shift in the reflected light, equivalent to the observed 19nm figure error measured using 533nm visible light, Figure 5. Performing the same calculation at EUV wavelengths, however, yields a figure error of only 1.3nm, a difference which is wholly attributable to the difference in optical constants between the two wavelengths: Figure 6.

Figure 5
Calculated figure error (left) and reflectivity (right) at visible light wavelengths (533nm) caused by a 29nm thick Gaussian-shaped carbon layer deposited on the surface on an EUV multilayer.

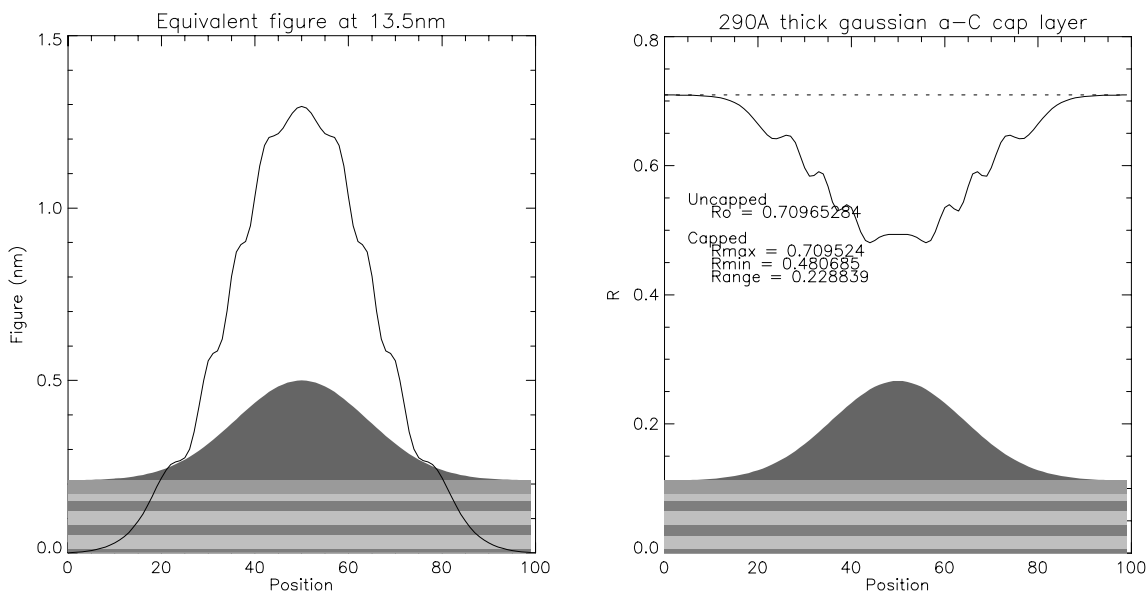
Figure 6
Calculated figure error (left) and reflectivity (right) at EUV wavelengths (13.5nm) caused by the same 29nm thick Gaussian-shaped carbon layer depicted in Figure 5.

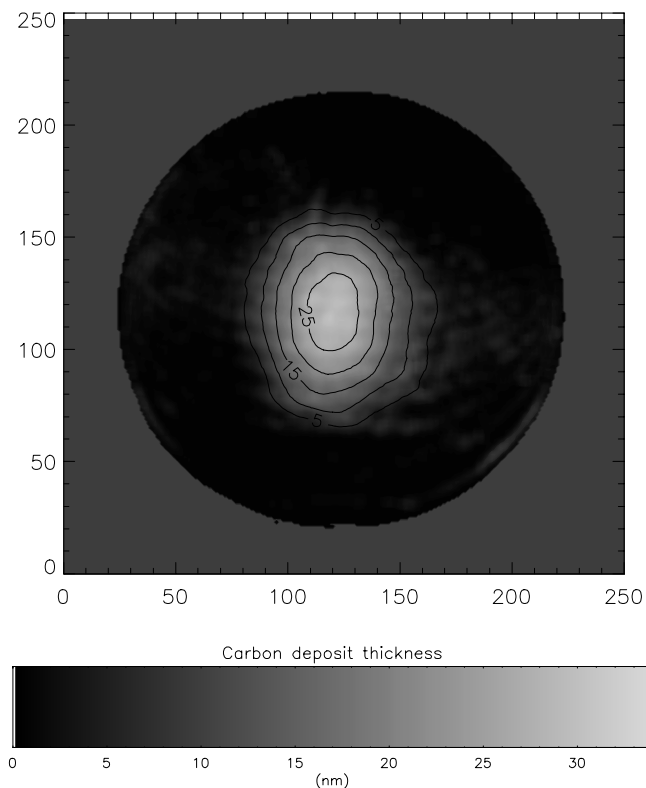
Figure 7

There is sufficient data in the above analysis to convert the measured visible light interferometry data to predictions about the figure and reflectance of the 10x optic at EUV wavelengths. For the sake of simplicity we attribute all of the observed difference in measured figure to the presence of carbon on the surface. The figure degradation mechanism is assumed to be due to carbon deposition, deposited in the form of bulk amorphous material. Applying this strategy to the measured figure data, and assuming that carbon deposition is the sole source of the observed figure error, we can convert the measured visible light figure data into a carbon thickness map, Figure 7.

Calculated carbon layer thickness based on measured visible light interferometry data.

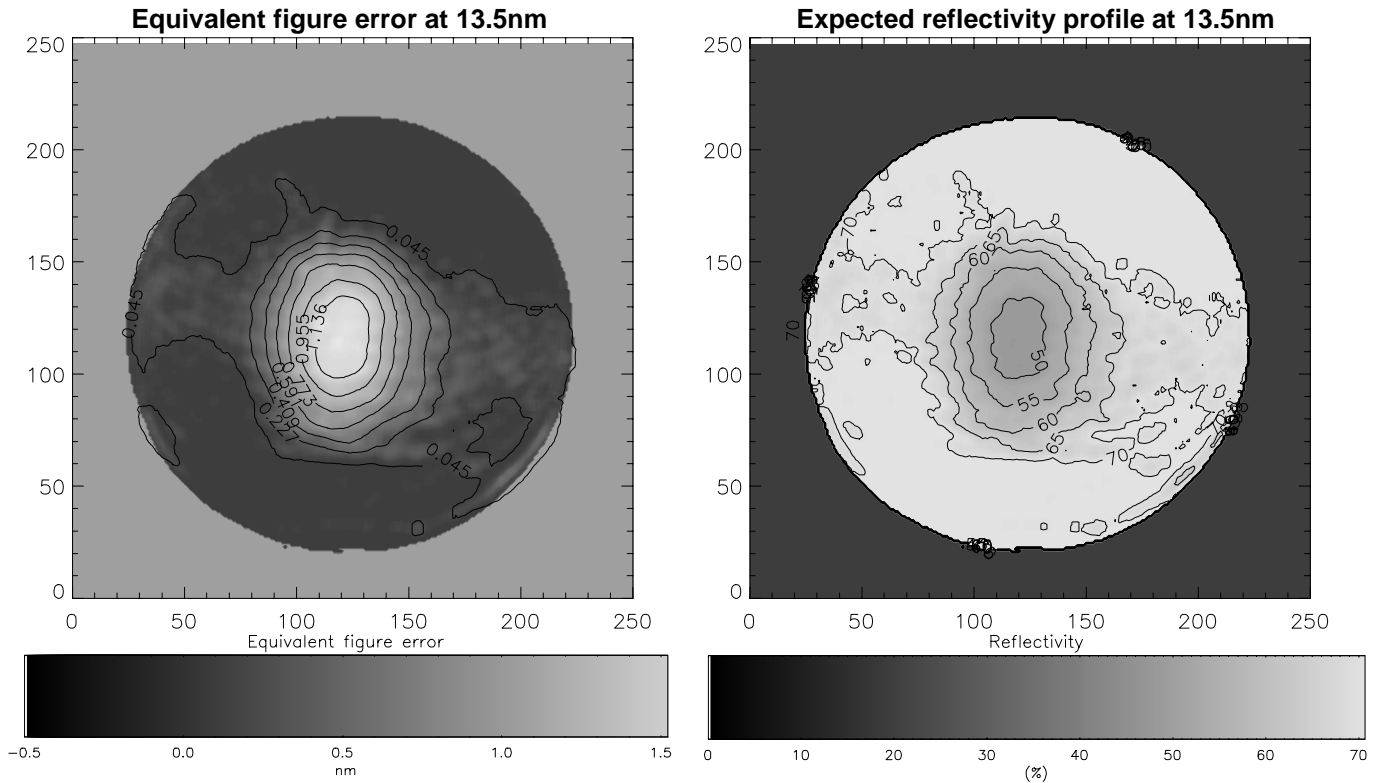
Given this carbon thickness map we can directly compute the predicted EUV figure and reflectance, Figure 8. Note that a wavefront error equivalent to a figure error of 1.3nm and a reflectivity drop of up to 22% at EUV wavelengths is associated with the deposition of a 29 nm thick carbon layer. Note also that the shape of the deposited carbon closely matches that of the 10x pupil fill. Configured for small-field lithographic exposures, the 10x pupil fill is approximately Gaussian in shape, with a partial coherence of σ=0.4 in the horizontal direction and σ=0.6 in vertical direction. A comparison the calculated carbon and the pupil fill parameters reveal that the carbon distribution closely matches the illumination footprint on the primary mirror.

Figure 8
Expected figure (left) and reflectivity (right) at EUV wavelengths calculated from the carbon thickness map Figure 7 and the EUV figure data in Figure 7.

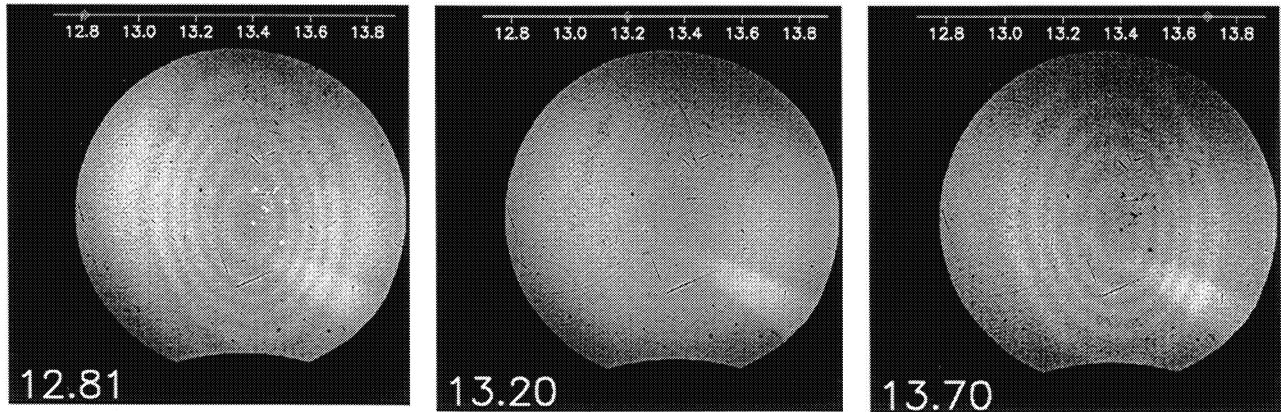
The used optic was also inspected at EUV wavelengths at beamline 12.0 at the Advanced Light Source (ALS) in Berkeley. Although system interferometry was not performed in this case inspection of the pupil plane intensity distribution revealed a set of concentric rings that changed position as the wavelength was tuned, as shown in Figure 9. This observation is consistent with interference thickness fringes formed by interference of reflections from the multilayer mirror surface and the top layer of a Gaussian surface deposit. This observation is once again consistent with the hypothesis of a deposition on the mirror surface in the shape of the pupil fill.

Figure 9
Carbon fringes observed on the 10x optics at three EUV wavelengths in the vicinity of 13.5nm. Note that the shape of the thickness fringes matches the pupil fill of the 10x camera, which is Gaussian in shape with a partial coherence of σ=0.4 in the horizontal direction and σ=0.6 in vertical direction.

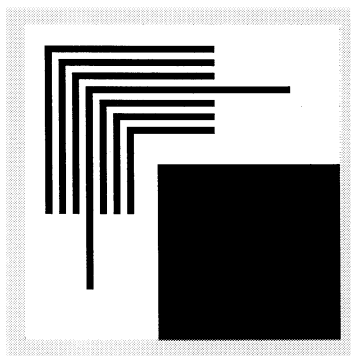
To assess the effect of the observed carbon contamination on lithographic performance we performed aerial image simulations of the contaminated 10x system. These calculations were performed using a test pattern consisting of 100nm isolated and dense features as shown in Figure 10, the known Gaussian shaped 10x pupil fill, and using the inferred absorption and phase data shown in Figure 8 for the contaminated 10x camera. The measured figure of the 10x optic after manufacture was also known and used to model imaging in the absence of the observed contamination. Using a simple threshold resist model at 40% the calculated

Figure 10
Nested elbow test object (left) consisting of 100nm isolated and dense features.

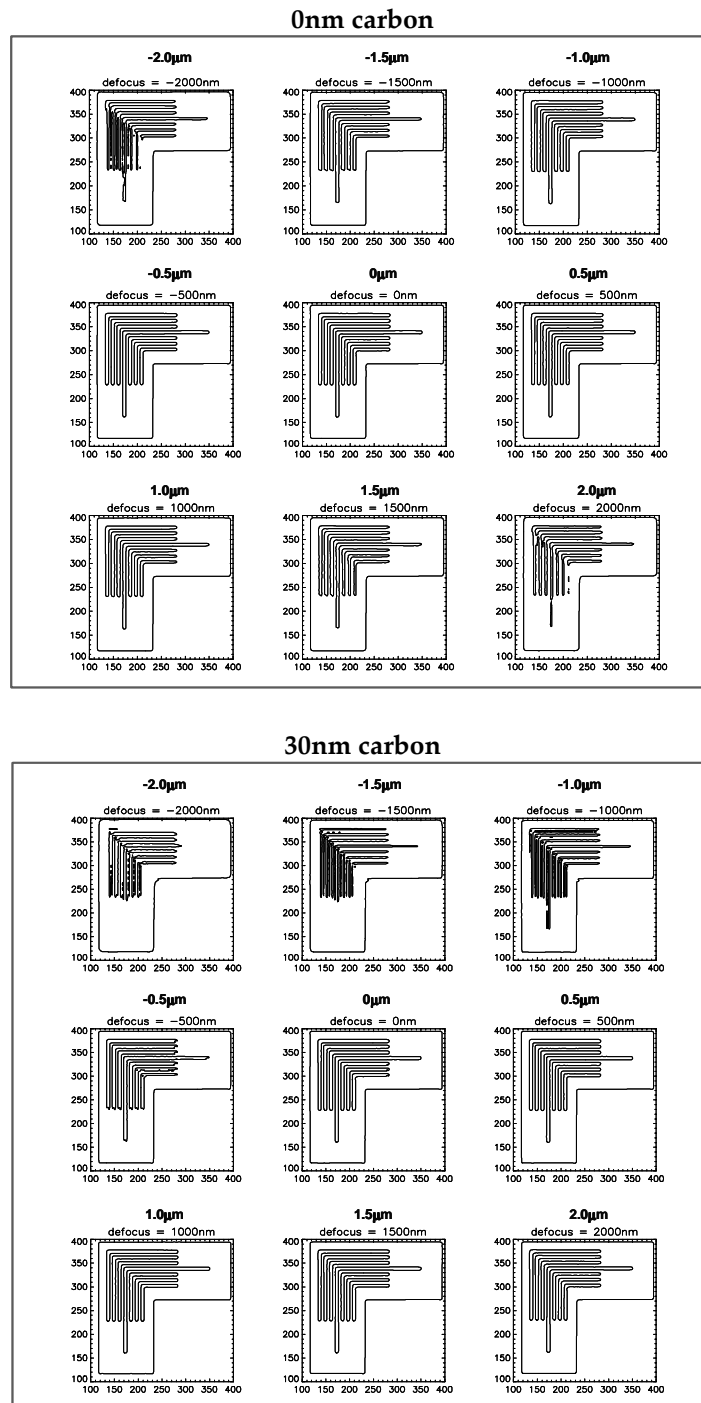
Figure 11

The effects of EUV-induced carbon deposition ion imaging performance are seen to be similar to the effects of spherical aberration, as would be expected from the shape of the carbon deposition. There is an appreciable shift in the plane of best focus and a loss of depth-of-focus with carbon deposition, whilst analysis of the original aerial images reveals a small decrease in contrast. The simulations were repeated for carbon depositions of several thickness' enabling trends in CD, contrast and defocus to be analysed as a function of contamination thickness, Figure 12. Inspection of this data shows that the most significant effect of carbon deposition is a change in focus, which can be compensated for by refocusing the tool, leaving a small change in contrast at large carbon thickness'. Interestingly there is little change in measured CD with carbon thickness. This is consistent with the observed changes in performance of this 10x camera over time, in particular a decrease in depth of focus and increase in line edge roughness (LER) observed in the printed resist image with no significant change in printed CD.

Aerial images through focus for a clean (top) and contaminated (bottom) 10x optic. Threshold is set at 40%, aerial images were generated using the figure and absorption inferred from the carbon thickness map, Figure 8, and the 10x pupil fill.

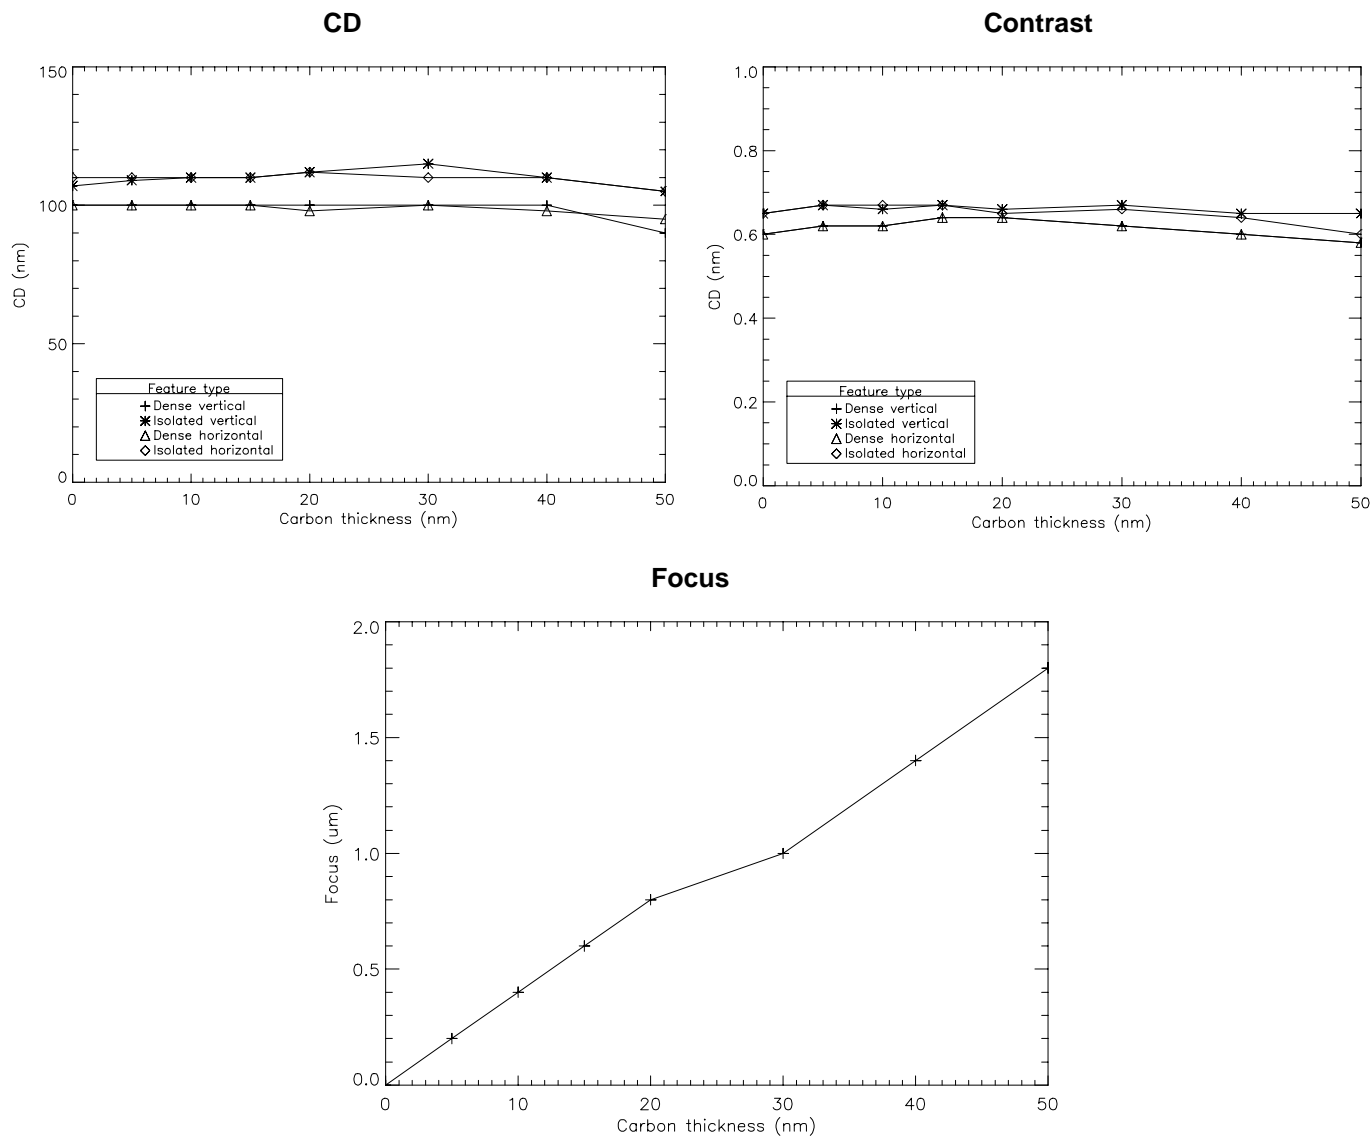
Figure 12

There are two main reasons why the aerial image performance is relatively insensitive to carbon deposition. Firstly, the EUV phase change associated with carbon deposition is relatively small compared to both the carbon layer thickness and figure measured at visible wavelengths: for the case examined here a 30nm thick carbon deposit was measured as a 19nm figure error using visible light, but caused only a 1.3nm figure error in the EUV. Secondly, carbon is absorbs EUV light, thus the throughput of the optic is reduced as a result of carbon deposition as expected. However the pupil is effectively apodised in the region of greatest figure error, further reducing the effect of the expected figure error on optical system performance.

Variation in measured CD (top left) aerial image contrast (top right) and defocus (bottom) with varying thickness of carbon deposition.
