# Repairing native defects on EUV mask blanks

Mark Lawliss<sup>a</sup>, Emily Gallagher<sup>a</sup>, Michael Hibbs<sup>a</sup>, Kazunori Seki<sup>b</sup>, Takeshi Isogawa<sup>b</sup>,  
Tod Robinson<sup>c</sup>, Jeff LeClaire<sup>c</sup>

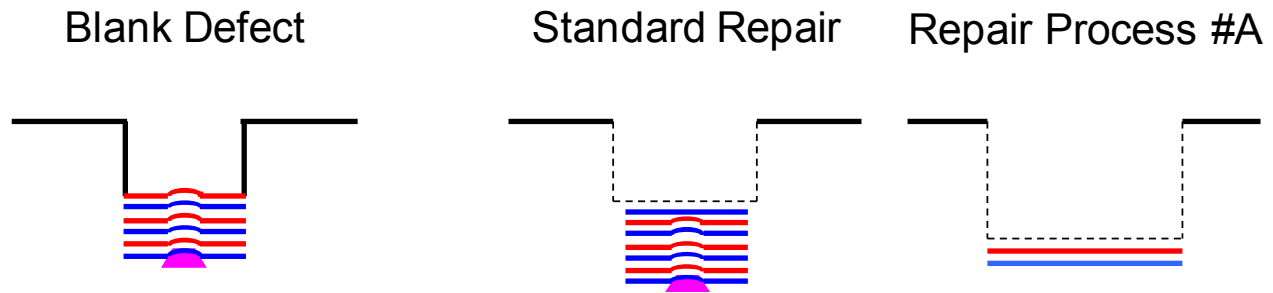
edge absorber bias to achieve good printability. This strategy may leave an insufficient reflectivity at a blank defect site if some of the foreign material remains embedded. For these defects, one theory suggests a more aggressive strategy with larger depth bias and larger lateral edge absorber bias. We call this method repair process #A. This process will involve a depth removal that will be even across the whole contact feature area. The increased depth bias may be effective in removing the embedded particle, while the lateral absorber bias will compensate for the reduced number of multilayers. Figure 4 below shows a schematic of a blank defect and the two repair strategies described above, with the repair process #A on the right. In all schematics, the purple shape indicates the defect area, but does not indicate defect composition nor defect mechanism.

**Figure 4.** Shown above are schematics of a blank defect on the left, the standard particle removal repair technique in the middle and a more aggressive repair strategy on the right. The more aggressive repair includes a depth bias removing multilayer pairs and absorber bias.

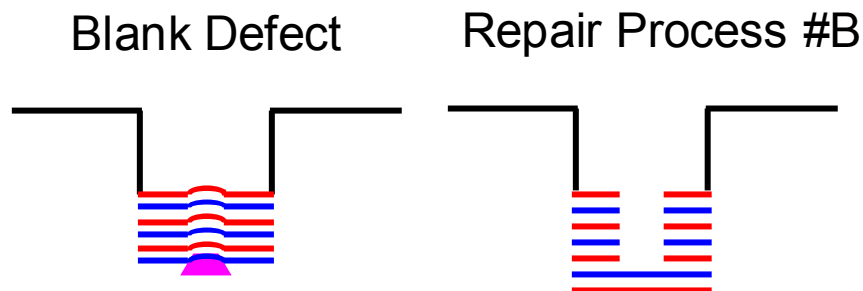
A second alternate strategy, repair process #B, will also be considered as part of this work. The targeted repair strategy will also remove multilayer material, but only in the immediate region of the defect area. Some edge absorber lateral bias may also be needed to achieve good printability. This method is shown in the schematic in Figure 5.

**Figure 5.** Shown above are schematics of a blank defect on the left, the a targeted repair strategy on the right in which multilayers are missing from the structure.

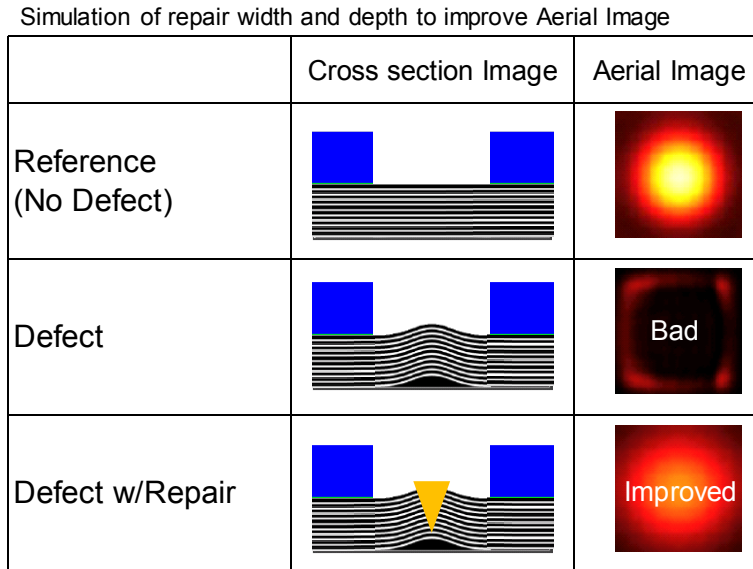
patterns in some previous work and resulted in Bossung curves that were flat through the process window of interest on these line and space simulations. [5] In Figure 6, the schematic shows both the simulated cross-section and the resultant aerial image for three cases. The bottom row illustrates one possible repair strategy and the improved aerial image.

**Figure 6.** Shown above are the 2D EUV mask stack input to the simulator and the associated aerial image created by EUV illumination. The top row is a reference space without any defect, the middle row introduces a defect and the bottom row shows one possible repair shape in yellow and the improved aerial image. Simulation can be used to explore repair parameters and recommend ones for repair on the mask that will improve the wafer aerial image.
